Roulette Balls: **THE INSIDE STORY**

Is it that players continue to place metal objects in roulette balls or is it mistrust of the electric cables that run down the side of roulette wheels — certainly, something still perpetuates the mystery that someone, somewhere is seeking an unfair advantage, says George Melas

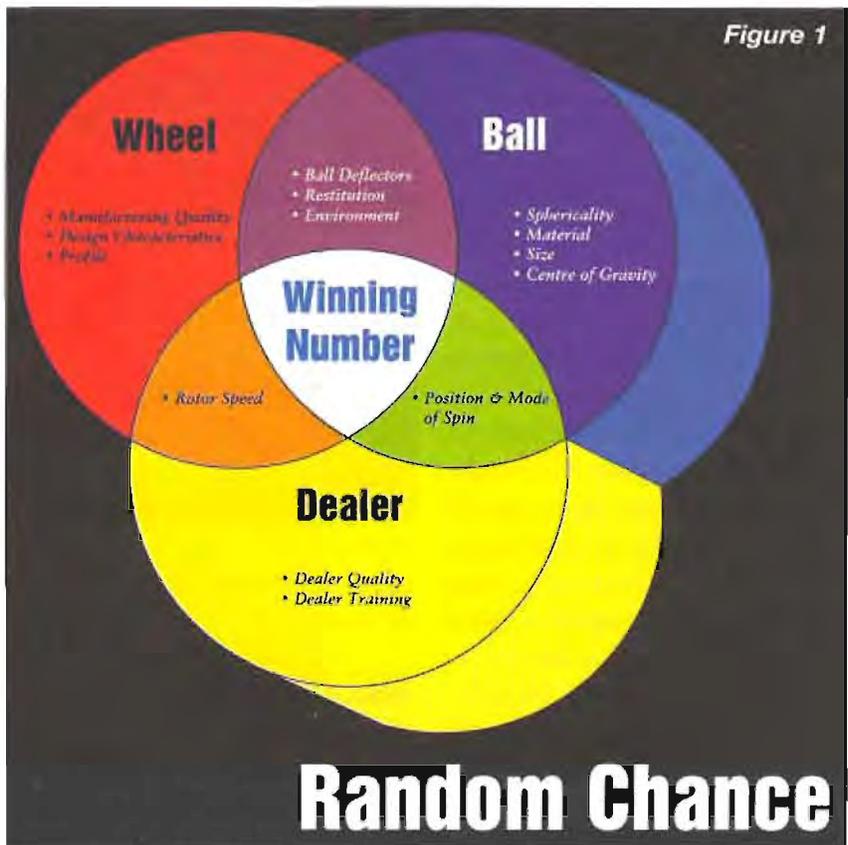
Figure 1

With mistrust running high on both sides of the tables, perhaps an explanation that is open to scrutiny may help to separate fact from fiction. Analysis by the author of the process by which Roulette is played shows that the factors whose interaction influences the eventual outcome of the game ‘The Winning Number’ can be classified under the headings: ‘Wheel’, ‘Ball’ and ‘Dealer’ — see *Figure 1*.

The Winning Number is determined by the chance behaviour of the ball falling into a numbered wheel pocket spun in the opposite direction to the ball. When the ball falls into the pocket, the winning number is declared and the game is over.

The interaction between the ‘Ball’ and the ‘Wheel’ defines the suitability of a particular ball for a given roulette wheel. Heuristic data suggests that some types of balls behave in a more random fashion than others of different mechanical characteristics. The ‘ran-

domness’ of the ball’s behaviour can be assessed in terms of the width of the winning number pattern; the more random the ball’s behaviour, the greater is this width or spread and vice versa.

The term ‘restitution’ refers to the ‘bounciness’ of the ball. The term ‘environment’ includes all environmental factors affecting behaviour, for example, the accuracy with which the ball track is horizontally aligned. The interaction between the ‘Ball’ and the ‘Dealer’ encompasses the speed and the direction of the ball’s rotation around the ball track and the position of the start of the spin with respect to the position of the last winning number.

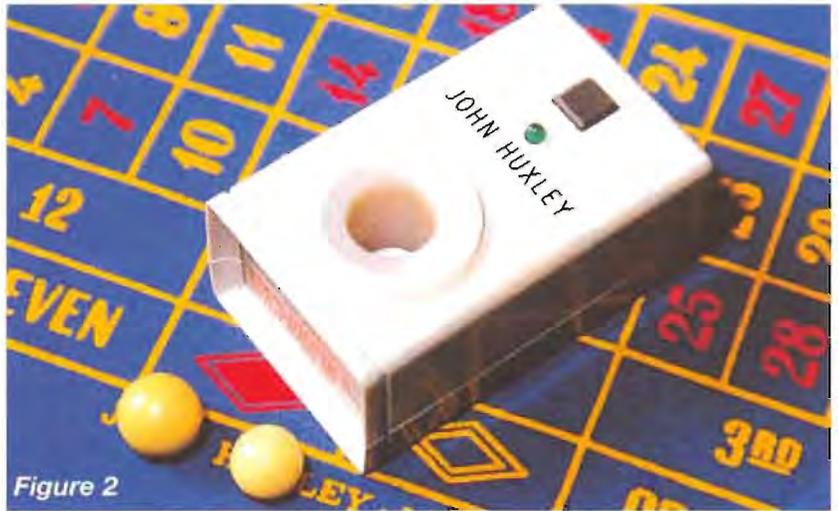
Figure 2

The units were marketed under the heading of 'ball verifiers' — see *Figure 2* — by John Huxley. Since then, with advancing technology, 'ball verifiers' have become smaller — see *Figure 3* — and more user friendly — see *Figure 4*. Recently John Huxley introduced a 'security kit' comprising several serialised roulette balls, a 'smart dolly', a 'ball verifier' and a patented anti push-bet bar.

Metal inserts can easily be detected using standard electronic techniques. The first electronic detector of this type to be used on the gaming floor was designed by the author in 1983 and employed a tuned circuit whose frequency would change with the

proximity of metal or conductive material. The ball was placed inside a receptacle, whereupon an indicator showed the presence or absence of conductive material in the balls.

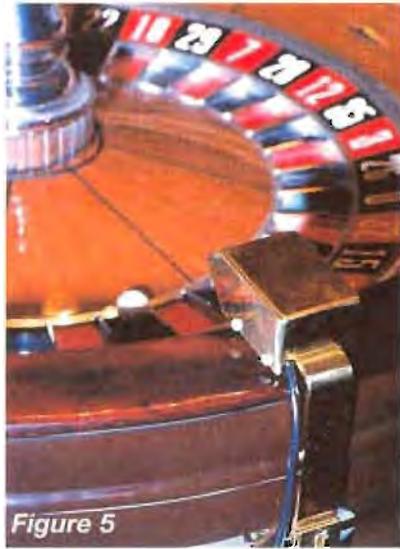
optical scanner — see *Figure 5* — and the electronic winning number display for something of a more sinister nature. With stories from the old Wild West era of unlicensed casinos and with the seeds of mistrust sown by certain publications such as Scarne's *New Complete Guide to Gambling*, it is hardly surprising that such an attitude of suspicion prevails.

It was natural for the retired Greek player to be alarmed at the presence of electric cables running down the roulette wheel, mistaking the signal wires from the

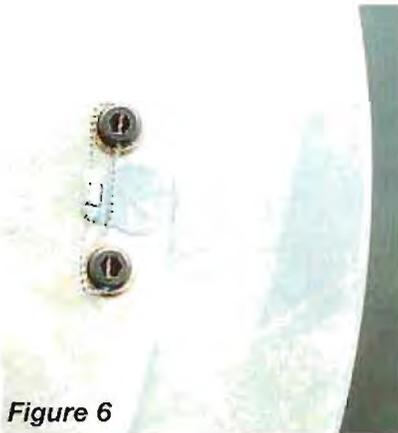
- Roulette wheels with factory installed security seals — see *Figure 6* — are inspected regularly by the casino security. The security seals are routinely broken by the manufacturer during maintenance or if the manufacturer wishes to confirm that no one has tampered with the wheels. If the seals are broken, for any reason, only the manufacturers have the means to replace them. It has been a standard procedure by reputable manufacturers to report broken security seals and to advise the management to withdraw the roulette wheel from the floor for further scrutiny;
